Project Description

In 2009 Network Rail decided that the up line through Bradley Junction was life expired and would not be able to carry the proposed increase in annual tonnage from 6 million to 11 million.

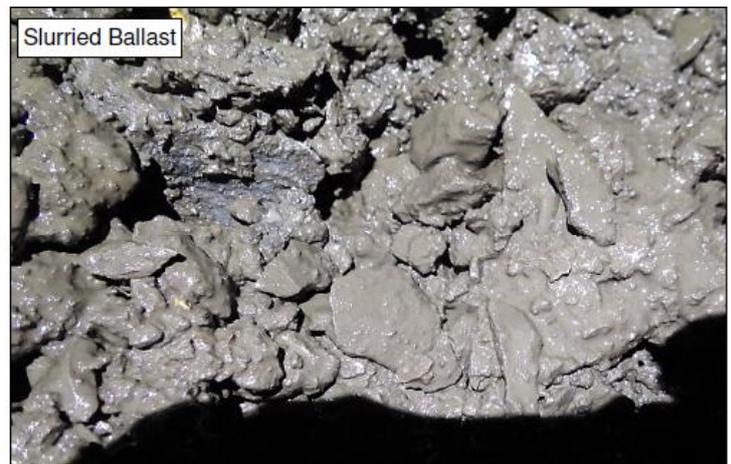
At SP1, where TrackTex was not present, formation failure and wetbeds are evident, with clay and slurry present within the lower trackbed layers and bottom of the ballast layer.

Close up of SP1 shows that where no Tracktex is present, formation failure is evident.

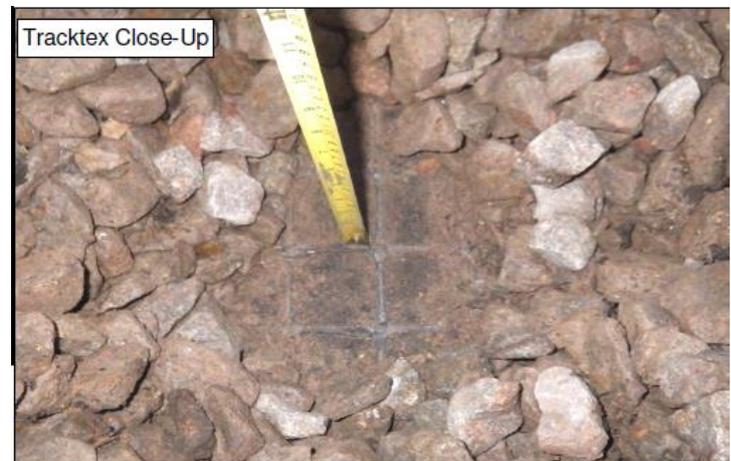
At SP 4 & 5, the Tracktex appears to be performing well in preventing the migration of clay fines from beneath and preventing any significant loss in the residual life of the ballast.

Close up of SP5 shows that where Tracktex is present, the composite is performing well and has prevented migration of the clay fines.
