Crossing Repair and Replacement using TrackTex – Dekalb, IL

Project Information

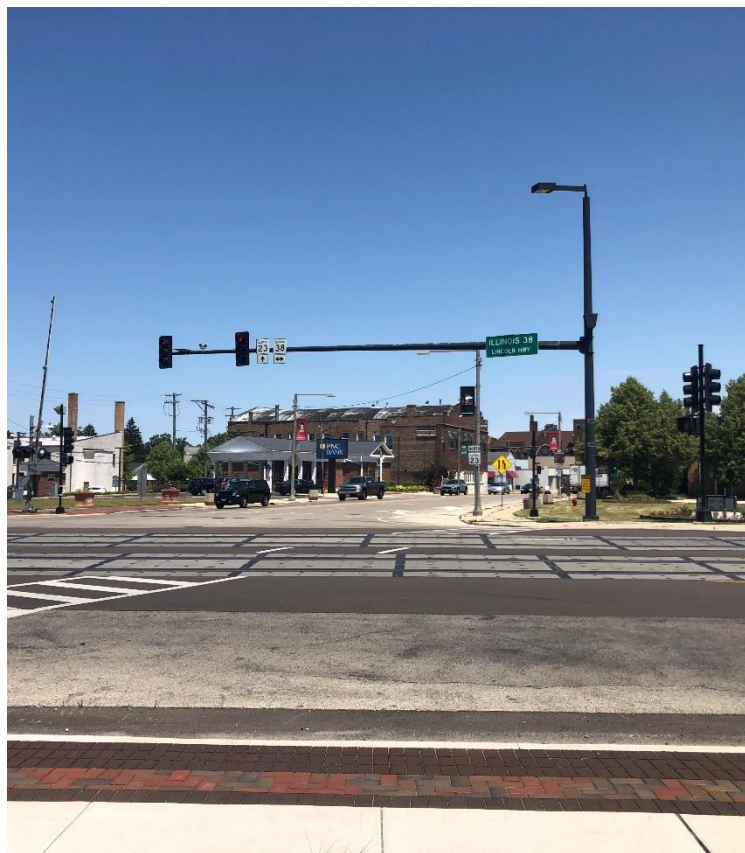
This road crossing had been replaced and repaired multiple times due to issues with track geometry movement and differential settlement of the highway and railroad. Union Pacific Engineers assessed the site and identified soil pumping as the root cause of the repeat problems. TrackTex anti-pumping geocomposite was selected as the preferred solution following success on other similar problem sites.

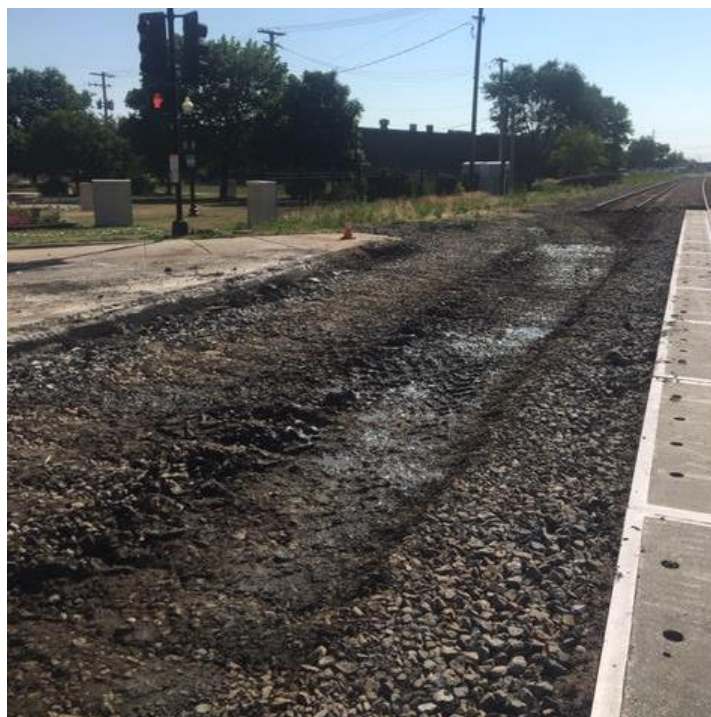
Mud-pumping reduces the ground bearing strength leading to settlement issues and costly repeated maintenance repairs

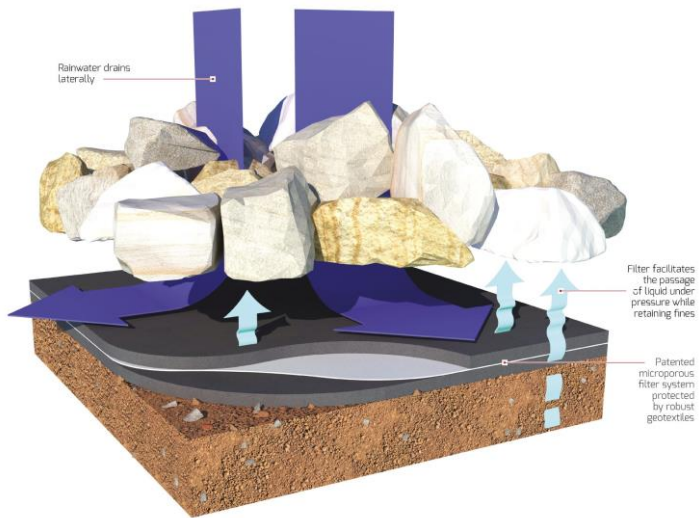
TrackTex is a multilayer composite with a unique microporous filter media protected by specially engineered protective nonwoven geotextiles. The filter is an orientated microporous polymeric film with a series of microcells and interconnecting pores, characterised by its relative strength and ability to transmit vapour.

Without pressure water cannot pass through the filter, but under pressure TrackTex effectively facilitates the passage of liquid. The pores are such that the passages of clay fines are not permitted meaning any underlying clay formation will, over time, dry out and have an improved modulus.

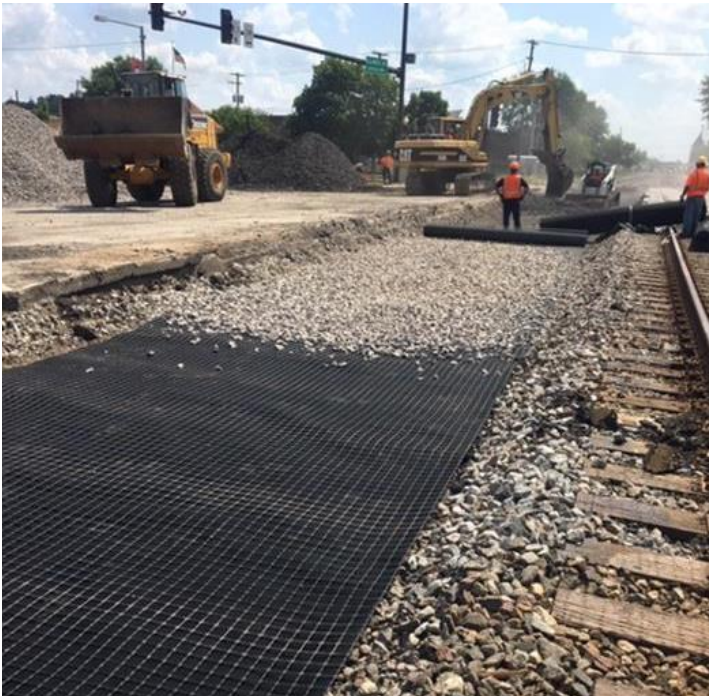
TrackTex was installed without the need for any specialist equipment.

When installed on a soft subgrade TrackTex can be used in conjunction with a geogrid, in this case a 30kN biaxial grid was used, to provide additional strength to the ballast.

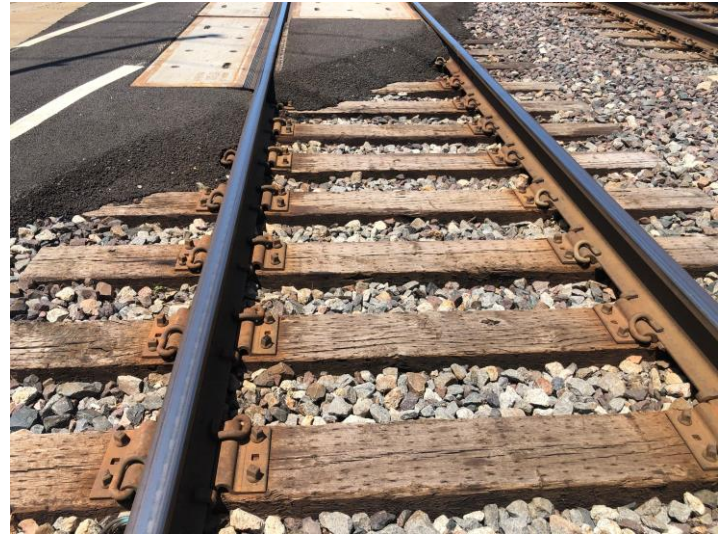
TrackTex prevents mud pumping so maintains the integrity and strength of the ballast

Monitoring of the site following installation has shown no recurrence of the differential settlement or track geometry movement. The ballast has remained clean with no signs of further mud-pumping.

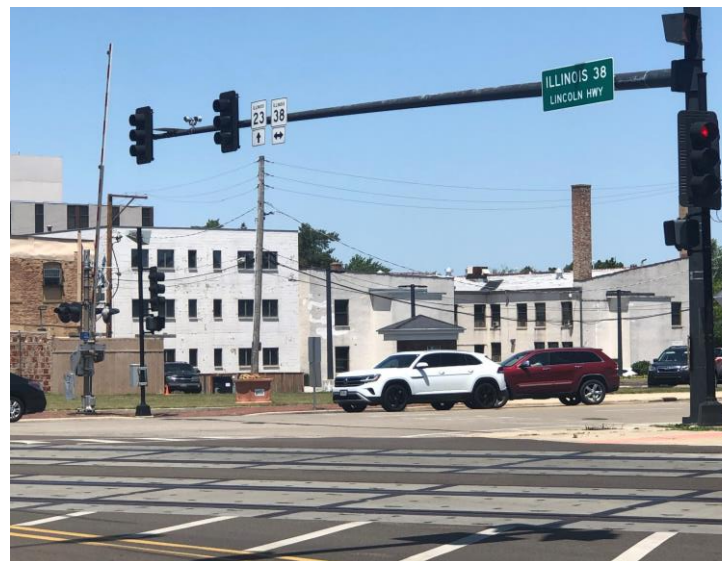
Following installation of the TrackTex the site has been monitored, with no further differential settlement problems reported to date
